Second Five-Year Review Report

Firestone Tire and Rubber Co. (Albany Plant) (EPA ID #: GAD990855074)

Albany Dougherty County, Georgia

December 2005

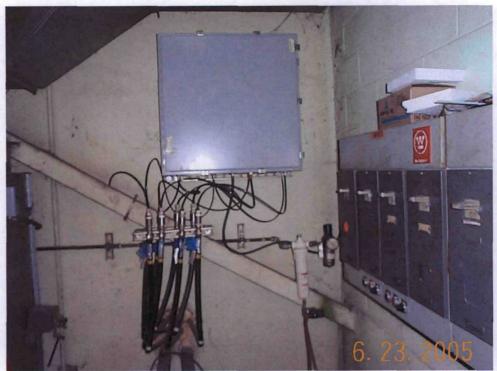
Photo: Extraction system control panel

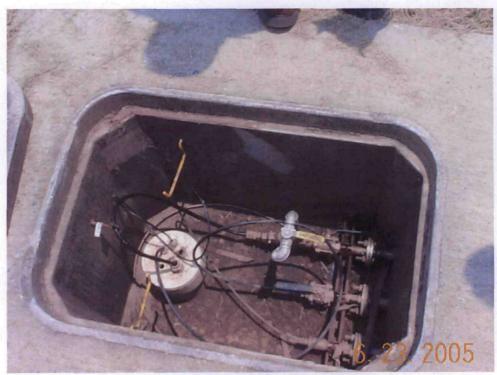
Photo: Extraction equipment piping at recovery well PTW-1

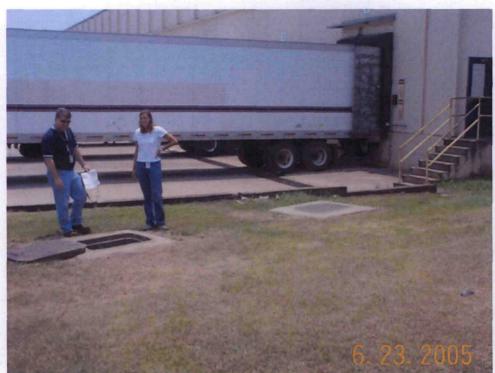
Photo: Recovery wells PTW-1 and MW-1-3

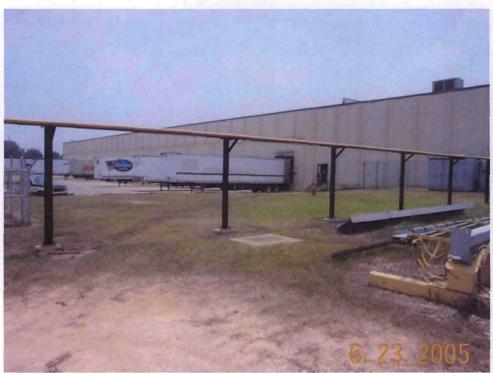
Photo: Looking from the courtyard at MW-1-1 and toward recovery well PTW-1

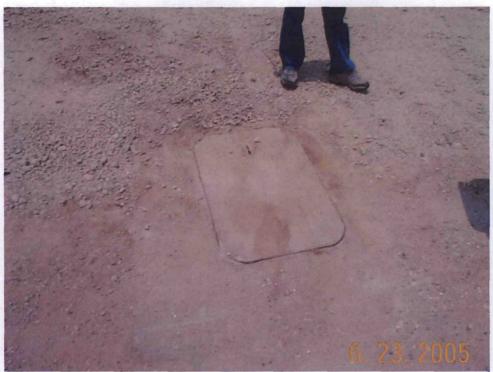
Photo: Monitoring well box for MW-1-2

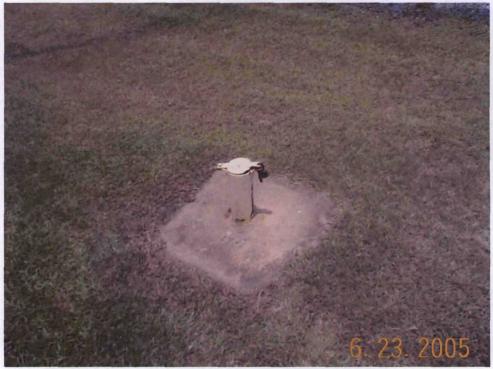
Photo: Monitoring well MW-1-4
